# Belzona Protects 6 Pump Impellers Against Cavitation Damage

Industry: Oil & Gas  
Application: CEP-Centrifugal Pumps  
Substrate: Steel  
Products: \* Belzona 1311 (Ceramic R-Metal) ,  
\* Belzona 1341 (Supermetalgilde) ,  
\* Belzona 2141 (ACR-Fluid Elastomer) ,

Customer Location: Saudi Arabia  
Application Date: 2018

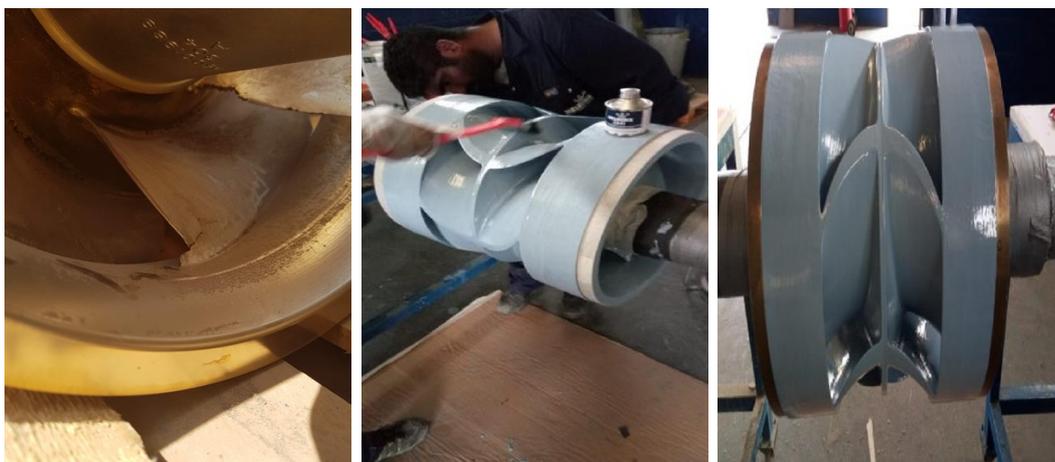
Impeller veins were experiencing cavitation which was reducing wall thickness and leading to through-wall defects.

- \* 1. Damage beforehand ,
- \* 2. Application in progress ,
- \* 3. Completed pump ,

The application was carried out in accordance with a modified version of Belzona Know-How System Leaflet CEP-1, after thorough surface preparation and cleaning, the damaged parts of the impeller were rebuilt with Belzona 1311. Then Belzona 1341 was used to provide protection before Belzona 2141 was applied to protect from cavitation.
