HOMELAND SECURITY RUSH JOB COMPLETED WITH BELZONA

ID: 788

Industry: Military
Application: FPA-Floor Problem Areas
Substrate: Steel deck & bulkhead
Products: Belzona® 4111 (Magma Quartz)

Customer Location: U.S. Coast Guard
Application Date: July 2006

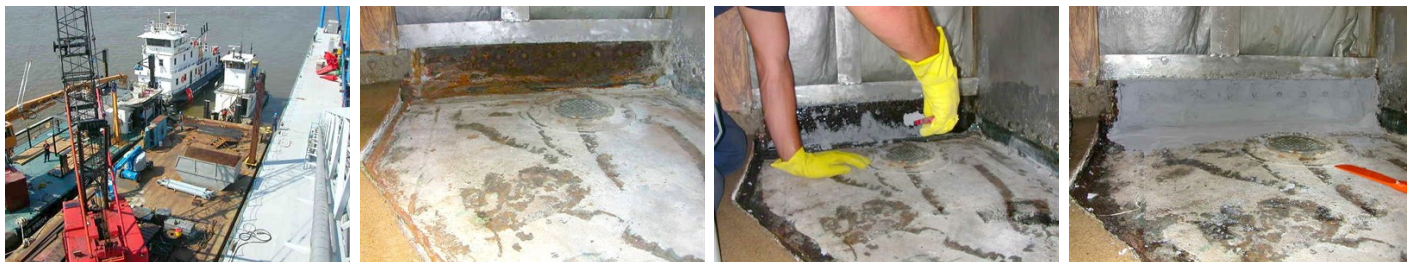
Photograph Descriptions

* The boat , * One of two problem areas , * Starting the repair , * Completed ,

Two old shower stalls on the boat allowed water to seep behind the stall walls rusting a 24" x 4" hole in the deck & leaked water into the engine room. The bulkhead was rusting badly as well

Belzona® 4111 applied in accordance with Belzona System Leaflet FPA-1 & the new shower base & sides installed in front of the repair while the material was still wet.
