# Rubber Lined Condenser Water Box Repair Requires Belzona

ID: 7880

Customer Location: Power Plant, Western Region of Saudi Arabia

Condenser Water Box

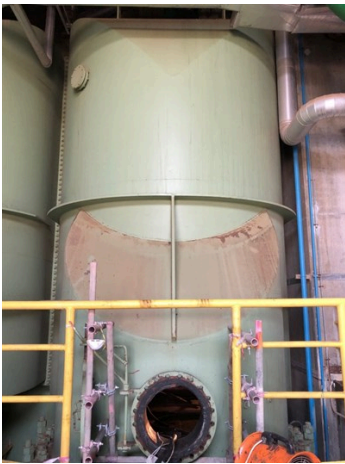
\* 1. Application overview 2. Close up of damage showing erosion and cavitation damage 3. The water box repaired with Belzona 1311 (Ceramic R-Metal) ,

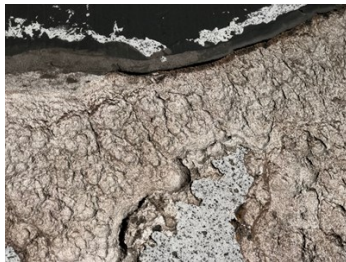
Inspection during the Power Plant shutdown showed severe erosion on the rubber-lined condenser water box, with thickness loss of around 5-6 millimeters in localised areas.

The repair was completed in accordance with system leaflet WPA-1. The rubber was undercut and all loose surface contamination was removed. After achieving correct surface preparation, Belzona 1311 (Ceramic R-Metal) was applied and contoured to the required profile.
