Repair of Concrete Support For Effluent Vessel

ID: 7890

Problem

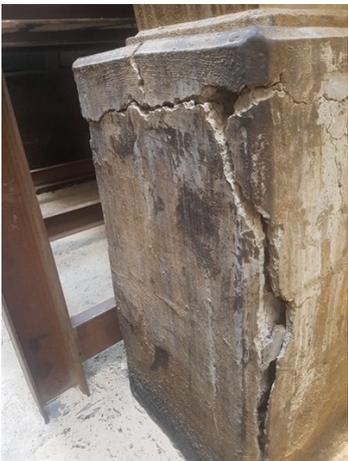
Damaged Concrete Supports of effluent water vessel: Water ingress and weathering had caused corrosion of the reinforcement bar leading to cracking and spalling of the concrete supports.

- * 1. Before application ,
- * 2. damaged and loose concrete was removed. ,
- * 3. Finished application ,
