# Repair of Concrete Support For Effluent Vessel

ID: 7890

Industry: Oil & Gas

Customer Location: Kuwait

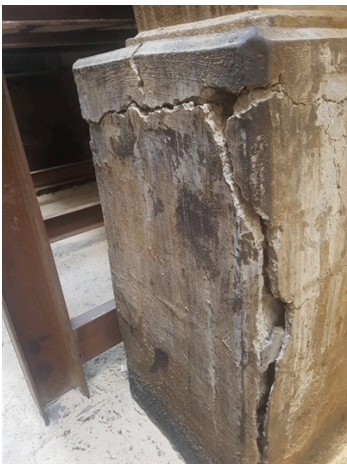
*Damaged Concrete Supports of effluent water vessel: Water ingress and weathering had caused corrosion of the reinforcement bar leading to cracking and spalling of the concrete supports.*

- \* 1. Before application ,
- \* 2. damaged and loose concrete was removed. ,
- \* 3. Finished application ,
