Belzona repairs a chassis on an air-cooling system

ID: 7894

Industry: Power

Application: FBC-Fans, Blowers and Compressors

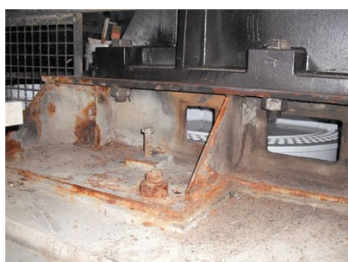
The water circulating in this equipment was treated with CO₂ and other additives against legionella causing an important problem of corrosion.

- * 1- Before surface preparation ,
- * 2- After surface preparation ,
- * 3- Overview of the air-cooling equipment ,
- * 4- Final application ,

Application was carried out in accordance with an adapted version of Belzona System Leaflet FBC-2. The substrate was first prepared with a needle gun and grit blasted. Then, one coat of Belzona 5831 was applied (600microns).
