# Belzona protects an SEC filter in a nuclear power plant

Industry: Power  
Application: CEP-Centrifugal Pumps  
Substrate: Copper  
Products: \* Belzona 1321 ,

Customer Location: France  
Application Date: January 2012

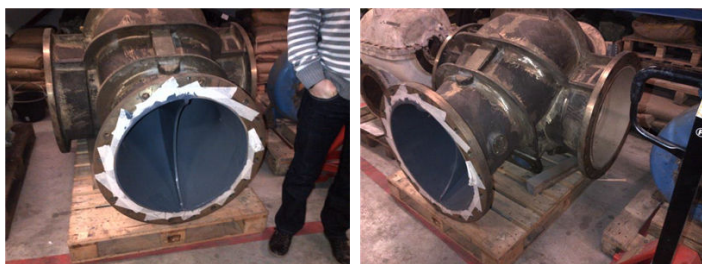
*The volute of this SEC filter was damaged by erosion. The micro-porosity generated by the erosion resulted in the oxidation of the copper visible from the outside.*

- \* 1- Finished application ,
- \* 2- Overview of the equipment ,

Application was carried out in accordance with Belzona System Leaflet CEP-5 After preparing the surface, 2 coats of Belzona 1321 were applied inside the filter (800 microns in total).
