Belzona repairs a vacuum pump casing and protects it against cavitation

ID: 7899

Industry: Power

Application: CEP-Centrifugal Pumps

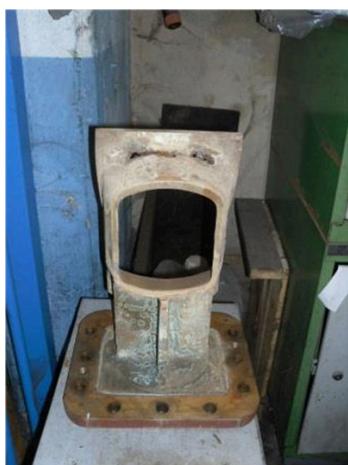
- * 1- Overview of the equipment ,
- * 2- Zoom on the damages ,
- * 3- Final application ,

Part of a casing on a vacuum pump

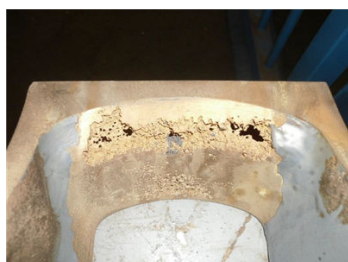
The casing of this pump was exposed to a severe cavitation causing important damages and perforations after only a few months.

Belzona 2311 was first used to rebuild the damaged area, then Belzona 2141 was used to protect the whole application against cavitation.
