Belzona SuperWrap II Seals Deteriorated Pipe Coupling

Customer Location: Natural gas power plant, California, USA
Application Date: November 2018

Flange coupling connecting a 32" cooling water bypass line for the power plants cooling tower.

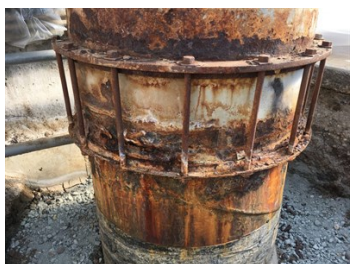
The pipe coupling was buried and therefore suffered severe corrosion below the ground.

- * Damaged coupling. ,
- * Application of Belzona 4141. ,
- * Application of Belzona Superwrap II. ,
- * Complete Application: Before & After ,
