Belzona Sacks an NFL Sized Problem

Industry: Buildings & Structures
Application: RPA-Roof Problem Areas
Substrate: Concrete
Products: * Belzona 2211 (MP Hi-Build Elastomer) ,
* Belzona 2911 (Elastomer QD Conditioner) ,

Customer Location: Sports Arena, Northeast USA
Application Date: 2018

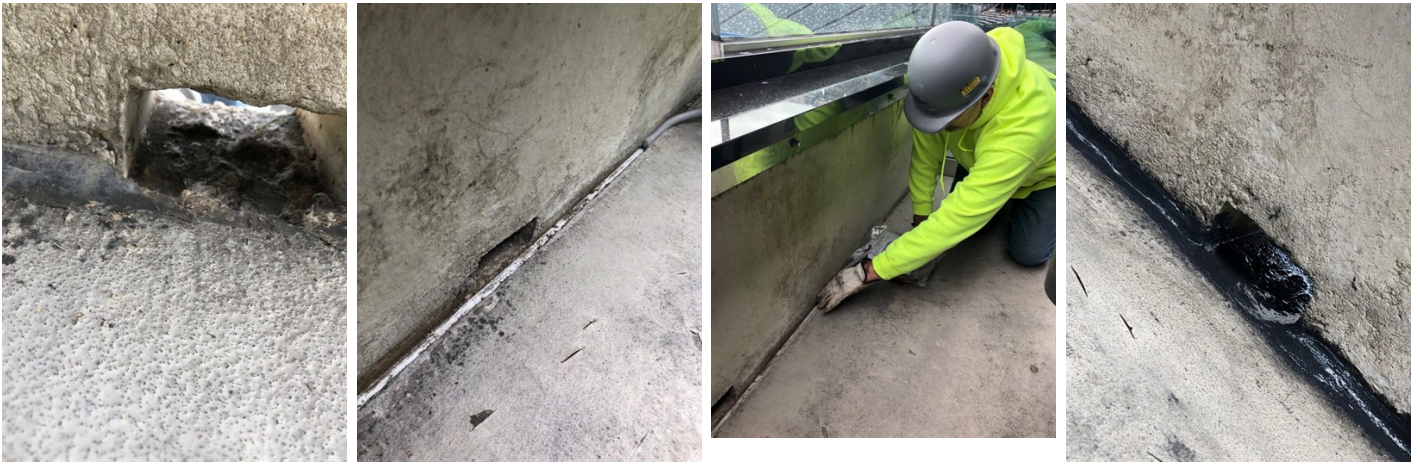
Photograph Descriptions

Poorly lined floor joints allowed water to seep through to lower seating levels of the arena. This water leakage resulted in a drip/slip hazard, concrete staining, corrosion, and damage to the beam and concrete structure below the luxury box suites. A walk-through revealed 32 problem areas measuring 11 feet in length each, causing leakages throughout the stadium. The lining replaced by Belzona was a failed flexible caulk.

- * Failed joint and drain. ,
- * Surface preparation in progress. ,
- * Application of Belzona elastomeric system. ,
- * Complete application. ,

95% of the old caulk material was removed using hand tools and the remaining 5% with an electric dremel tool with sand/stone bit to clean the joint's sides. The previous bond breaker was fully intact and reusable after minor prep. The application proceeded with the cleaning and degreasing of the joint with acetone followed by a pass of vacuum. The area was taped off using Gorilla Tape to

protect the wall and floor sides while Belzona 2911 was applied to the entire joint area and drain box area. After proper cure was established within the re-coat window, Belzona 2211 was mixed and applied by a stiff brush, spatula and custom cut applicator tools. The application was carried out in accordance with a modified version of Belzona Know-How System Leaflet - RPA-1.

Upon curing of the initial application the customer was pleased by the visual aesthetics of the job. Following the application the customer performed two water tests and experienced a weekend of heavy rain. The application held up, allowing no water to pass through the Belzona-repaired area. The application of the remaining 31 problem areas was requested following the success of the sample application.
