# Belzona Rebuilds the the Shredder Housing Lid

ID: 7916

Customer Location: Fruit Processing Plant, South Africa  
Application Date: 2015

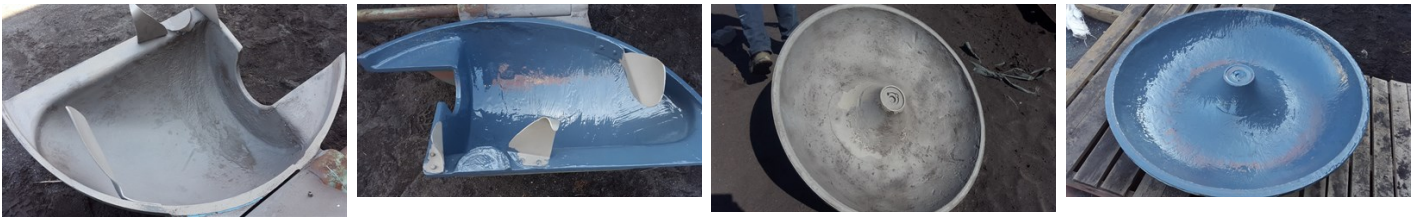
## Photograph Descriptions

- \* 1. Damaged lid ,
- \* 2. Lid protected with Belzona ,
- \* 3. Bottom dome prior to application ,
- \* 4. Dome protected with Belzona ,

Hard mango pips were dimpling the shredder housing lid. Eventually, oversized pieces of Atchar were being caught up in the filtering screens.

Application was completed in accordance with Belzona Know-How System leaflet CEP-3. The lid and the bottom dome have been grit blasted in preparation for the coating. Then, Belzona 1321 was applied as a two-coat system. The whole application took 4 hours to complete at a fraction of the cost, comparing to the purchase and installation of the new 316 ss apparatus.

This application was inspected in 6 months with no defects noted on the lid or dome. The solution is in tact today, enabling them to produce some of the finest quality mango atchar!
