Belzona Repairs Vibration Damage in a Slacker Chute

Industry: Pulp & Paper
Application: VPF-Valves, Pipes and Fittings
Substrate: Stainless steel
Products: * Belzona 1111 ,
* Belzona 1341 ,

Customer Location: Paper Mill - Elands Valley, South Africa
Application Date: 2015

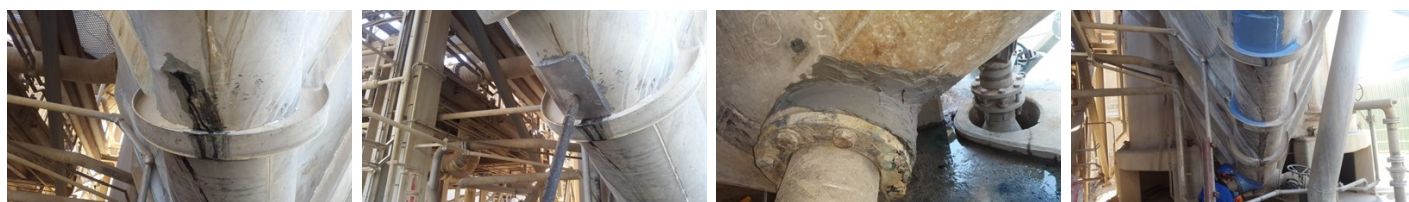
Photograph Descriptions

- * 1. Through-wall defect on slacker chute ,
- * 2. Steel patch bonded into place ,
- * 3. Belzona 1111 also used to seal a deteriorated drain valve ,
- * 4. All repairs coated with Belzona 1341 for additional protection ,

Due to an increase in the plant's production, a new slacker chute was installed in 2015. During the chute's operation, there would be intermittent vibration causing bearing wear. It also resulted in the screw flights coming into contact with the shoot body on the preload and discharge sides, thinning out the stainless steel.

The application was carried out in accordance with Belzona System Leaflet VPF-1. At the top of the chute, a through-wall defect had emerged. A 3mm-thick stainless steel plate was rolled to shape and bonded in place over the defect using Belzona 1111 (Super Metal). This was supported by a metal pole to keep the plate in place during cure. In addition, a drain valve at the bottom of the shoot had developed a through-wall defect. This was repaired also using paste-grade Belzona 1111. Finally, both repairs were then fully encapsulated with Belzona 1341 (Supermetalgilde).
