Flexibility Meets Durability with Belzona

ID: 7921

Problem

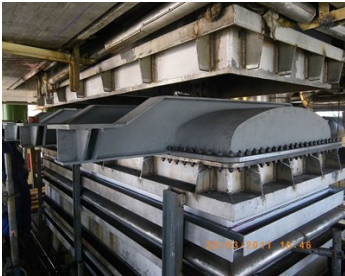
The bolted joint connections (3 joints in total) between the condenser and vapor turbine were experiencing vacuum loss around the bolts and joints. This occurred due to design change and alterations of the joints, resulting in efficiency loss and high cost. The client required flexible, yet tough system to encapsulate the joints and fully seal against the vacuum loss experienced on site, whilst providing excellent corrosion protection at the same time.

- * 1. Joints before repair, leaking in some areas ,
- * 2. Work area isolated for safe working ,
- * 3. First layer of Belzona 2121 applied to seal joints ,
- * 4. Completed application ,

The application was carried out using a modified version of Belzona Know-How System Leaflet GSS-1. As it was not possible to disassemble, the Belzona materials were used to cover the seal area from the outside. The repair area was grit blasted and once the leaking points around the bolts have been identified, Belzona 1212 was used to seal. The repair area was then treated with Belzona 2911, followed by Belzona 2121, reinforced with Belzona 9341 Reinforcement Sheet to fully encapsulate the bolts and joints.
