Belzona Protects Brand New Fertilizer Plant

ID: 7928

Industry: Other
 Application: TCC-Tanks and Chemical Containment Areas
 Substrate: Concrete
 Products: Belzona 4311 (Magma CR1),
 Belzona 4151 (Magma-Quartz Resin),

Customer Location: Hungary
 Application Date: 2007

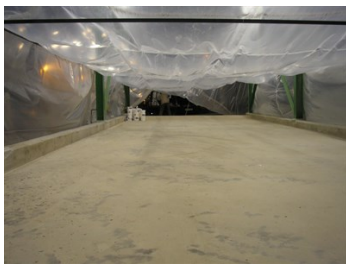
Application area being tented out

Application was carried out in accordance with Belzona Know-How system Leaflets TCC-15 and TCC-08. The outside area was tented out and the new concrete was coated with Belzona 4311. A special mortar mix of Belzona 4151 and AL203 ceramic aggregate was made for the 2 pads for the tractors feet to rest on, yellow tinted Belzona 4151 safety lines were also applied to help the driver park the tractor easily.

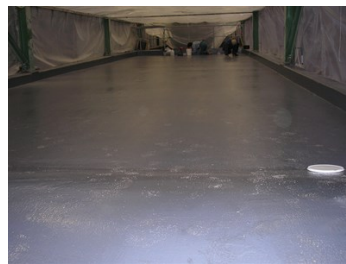
Belzona 4311 after being applied

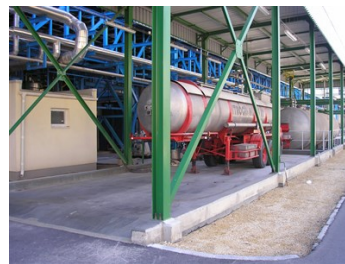
Coated fertiliser plant area

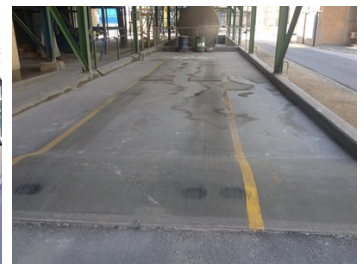
Wear pads and flooring system 8 years later

Over the years it was found that when the tractor picked up the tanker it would push it 10-20 cm backwards, damaging the Belzona 4311 coating with it's metal feet. To prevent this 2 wear pads were mixed and applied. 8 years later and the system is still in good condition.
