# BELZONA OPTIMIZES THE EFFICIENCY OF A DISTRIBUTION CHAMBER

ID: 7958

Customer Location: France  
Application Date: September/October 2013

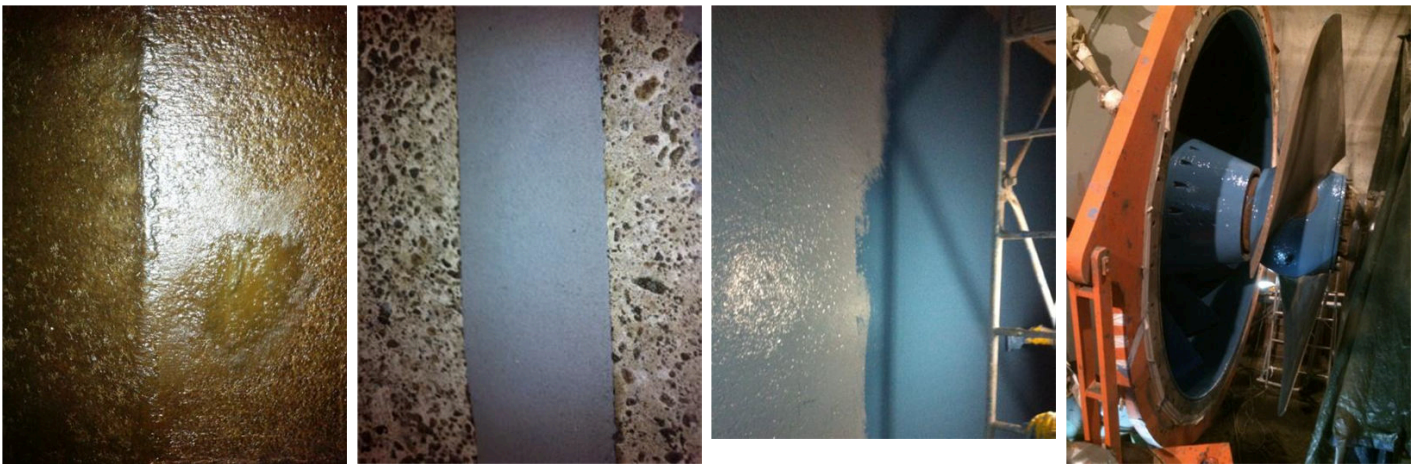
## Photograph Descriptions

*Due to an important flowrate of water from the river nearby, the surface of this distribution chamber, which had not been protected before, was badly damaged and needed to be rebuilt. The sharp angles of the concrete inside the chamber cause a resistance to the water flow, besides, the steel surface is badly corroded.*

- \* 1- Sharp angle on the concrete ,
- \* 2- Reconstruction of concrete ,
- \* 3- Application of Belzona 1341 ,
- \* 4- Final application ,

All the damaged parts of concrete were removed, then both substrates were grit blasted. The concrete substrate was rebuilt using Belzona 4111 using a modified version of Belzona System Leaflet FPA-1. Belzona 1341 was then applied on the steel and the concrete according to the Belzona System Leaflet CEP-10.

The customer was really satisfied with the application and observed an increase in the equipment efficiency.
