# Belzona Repairs and Protects the Internal Surface of a Scrubber

Application: TCC-Tanks and Chemical Containment Areas

Internal surface of a scrubber

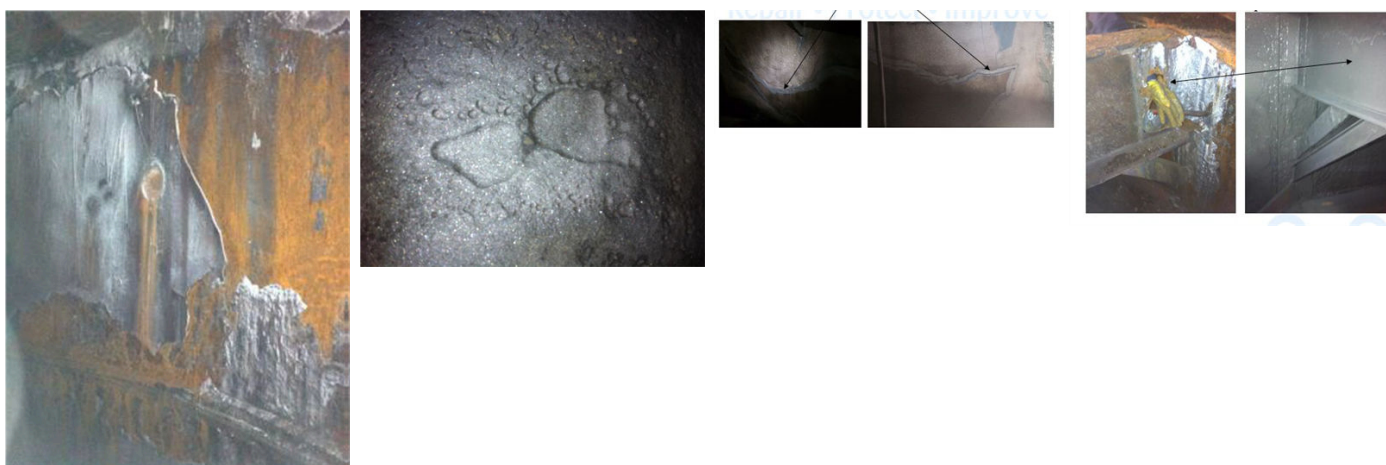
The internal surface of this scrubber was badly damaged due to chemical attacks at 90degC (sodium bicarbonate). The equipment presented important holes and needed to be rebuilt and protected, especially as the previous ebonite coating failed.

- \* 1. Before application ,
- \* 2. Zoom on the pitting ,
- \* 3. Repairs with Belzona 1111 ,
- \* 4. Before/after comparison ,

Belzona 1111 was used to rebuild the damaged areas and fill the important holes. Then Belzona 1391S was used to protect the whole application. This application has been carried out according to Belzona system leaflets TCC-3.

In December 2017, the application was still in perfect condition.
