# BELZONA RESTORATION OF HISTORIC FEDERAL BUILDING

Application: RPA-Roof Problem Areas

Application Date: September 2006

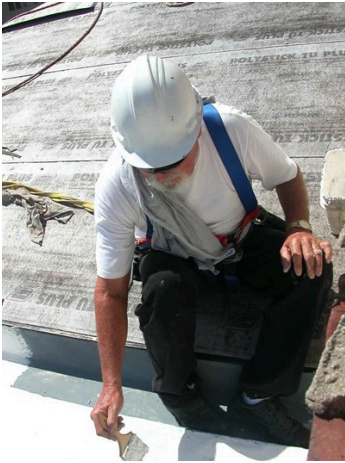
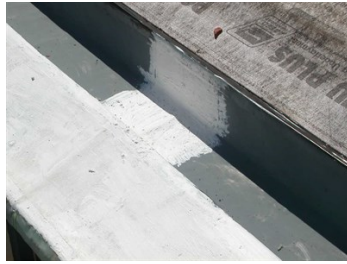
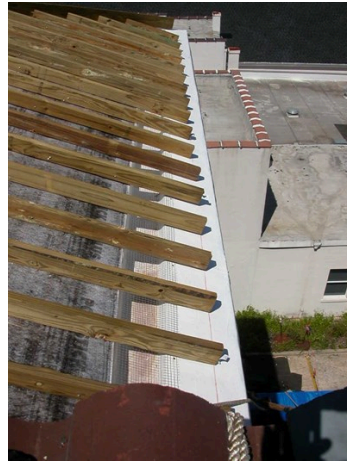
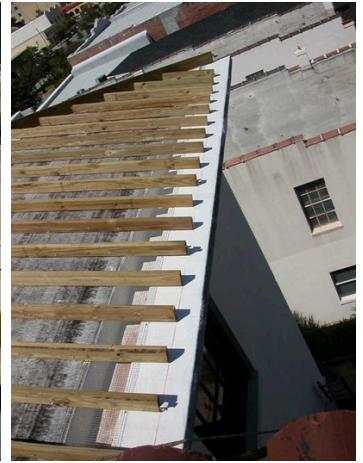
## Photograph Descriptions

The copper gutters had to be maintained watertight without replacement.

- \* Belzona® 3111 being applied ,
- \* Belzona initially applied to gutter seams ,
- \* View of the finished gutter system coated with Belzona® 3111 ,
- \* Another view of the finished gutter system coated with Belzona® 3111 ,

Copper gutters of historic site. Gutter system is part of the original structure and it is not permitted by the Federal Government to change materials.

Application was carried out in accordance with Belzona System RPA-6. Power wire brushing and degreasing was carried out prior to application.

There was no way to replace the copper gutter system as dictated by the Federal Government. Alternatives such as silicone sealants would not provide required longevity. Belzona® 3111 was chosen due to the ability to coat the copper gutter system and maintain its functionality without removal. It maintained appearance to the satisfaction of the engineers.
