BELZONA RESTORATION OF HISTORIC FEDERAL BUILDING

Application: RPA-Roof Problem Areas

Customer Location: Pensacola, Florida

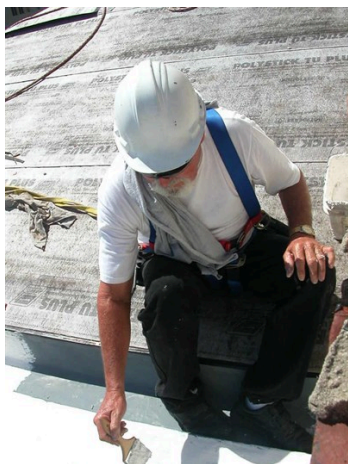
- * Belzona® 3111 being applied ,
- * Belzona initially applied to gutter seams ,
- * View of the finished gutter system coated with Belzona® 3111 ,
- * Another view of the finished gutter system coated with Belzona® 3111 ,

Application was carried out in accordance with Belzona System RPA-6. Power wire brushing and degreasing was carried out prior to application.
