# Belzona Stairway to Heaven

**Industry:** Buildings & Structures  
**Application:** FPA-Floor Problem Areas  
**Substrate:** Ceramic Tiles  
**Products:** \* Belzona 5321 (SG Laminate) ,  
\* Belzona 9221 (Surefoot Aggregate White) ,

**Customer Location:** Croatia, Zagreb  
**Application Date:** June 2018

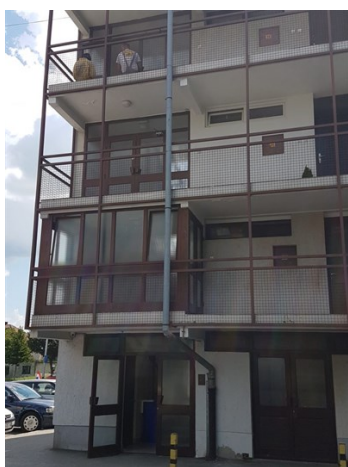
- \* 1. Block at flat of where the application was taking place ,
- \* 2. Previous cheap adhesive tape solution ,
- \* 3. Belzona 5321 being applied ,
- \* 4. Finished application ,

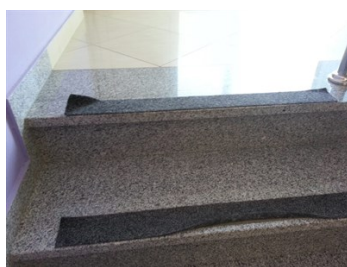
The customer had previously installed several types of cheap adhesive tapes which all lasted a very short time and didn't perform well. Since this was an indoor application and the distributor knew that the price would be an issue. One coat of Belzona 5321 with Belzona 9221 (Sure-foot Aggregate) incorporated was recommended. 2 packages of Belzona 5321 (Dark Grey, 4 liters each) and 5 packages of Belzona 9221 (2 kg each) were used.
