Belzona protects large bund from chemical attack

Application: TCC-Tanks and Chemical Containment Areas

Substrate: Concrete

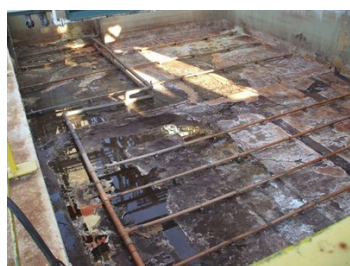
The aggressive chemicals have caused severe damage to the existing coating and the concrete beneath causing environmental concerns.

- * 1. Initial condition before repair ,
- * 2. Belzona coating applied ,
- * 3. After 1.5 years in service ,
- * 4. Second view after 1.5 years in service ,

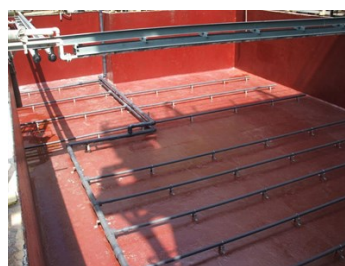
A previous coating has failed to last after a short time in service. The customer required a long lasting coating to prevent the possibility of degradation of the concrete, which could lead to spillages into the ground. The customer had previous experience with Belzona solutions for various applications including pumps, composite patches, composite pipe wraps and more - and so had confidence that Belzona could deliver a solution for this application. After 1.5 years in service, the area was revisited and found to be in excellent condition.
