# Internal of a Scrubber rebuilt with Belzona

ID: 7969

Industry: Oil & Gas  
Application: TCC-Tanks and Chemical Containment Areas  
Substrate: Steel  
Products: \* Belzona 1511 (Super HT-Metal),  
\* Belzona 1391T,

Customer Location: France  
Application Date: December 2013

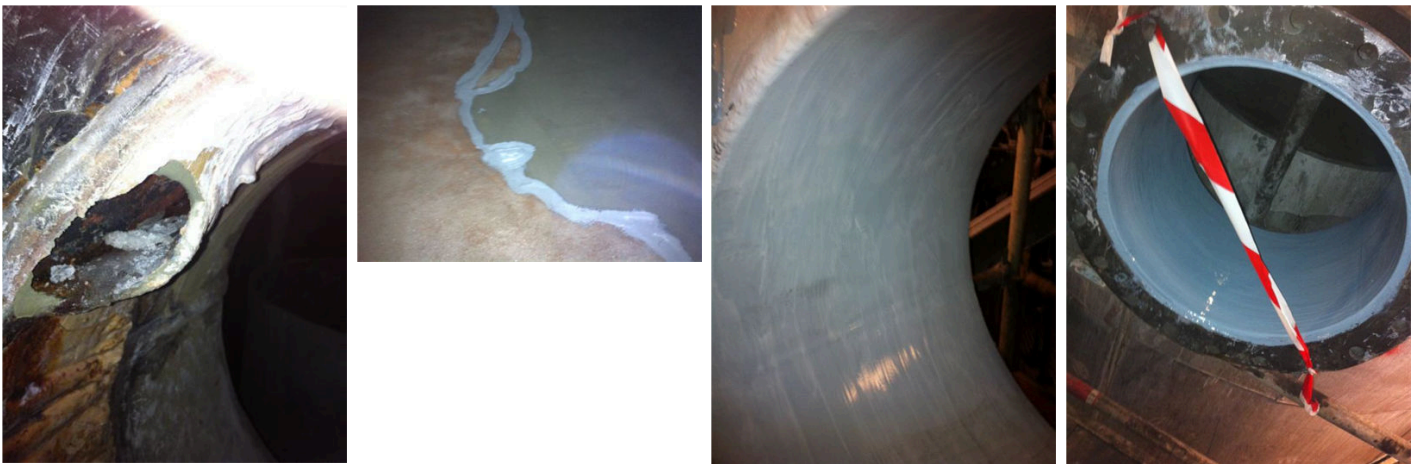
The internal surface and the ebonite coating of the scrubber were badly damaged by the rough conditions of the process (temperature up to 90degC and presence of chlorides and ammonia).

- \* Before application ,
- \* Junction between substrate and ebonite coating, chamfered with Belzona 1511 ,
- \* After application of Belzona 1391T ,
- \* Final application ,

The substrate was first grit blasted to take off the damaged parts of the ebonite coating and roughen the surface of the steel. Then, the junctions between the ebonite coating (still in good condition) and the steel were chamfered with Belzona 1511. Finally, the whole area was protected with Belzona 1391T. This application has been conducted according to Belzona system Leaflet TCC-5.
