# BELZONA RECONSTRUCTS THE COVER AND FLANGE OF A HEAT EXCHANGER

Application: HEX-Heat Exchangers

Customer Location: Petrochemical Plant, Gabon

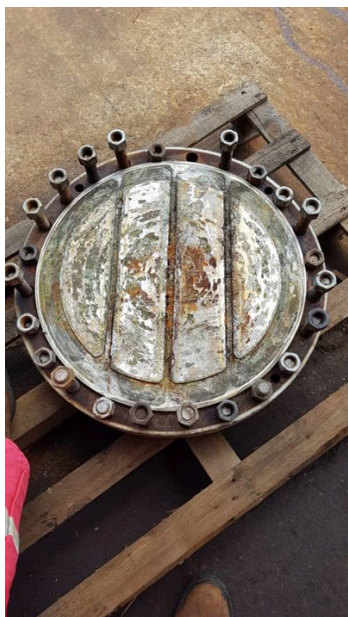
The flange and the cover of this exchanger were badly damaged by corrosion and needed to be rebuilt.

- \* 1- Cover before application ,
- \* 2- Flange before application ,
- \* 3- Flange after application ,
- \* 4- Cover after application ,

The substrate was first grit blasted to ensure a good mechanical bond with the product. Belzona 1111 was then used to rebuild the cover and the flange according to a modified version of Belzona System Leaflet HEX-02. Finally, the 2 parts of this equipment were machined back to the correct dimensions.
