# BELZONA SEALS HOTEL POOL DECK

**Industry:** Buildings & Structures  
**Application:** FPA-Floor Problem Areas  
**Substrate:** Concrete  
**Products:** \* Belzona® 4111 (Magma Quartz) ,  
\* Belzona® 3121 (MR7) ,

**Customer Location:** Hotel, Pensacola Florida  
**Application Date:** September, 2001

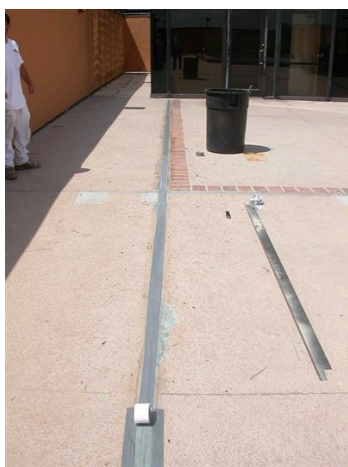
- \* Stress cuts in concrete ,
- \* Belzona® 4111 with drain in place ,
- \* Finished drain area ,
- \* Finished pool deck ,

Pool Deck leaking water down into the hotel kitchen and maintenance area.

Belzona® 4111 applied to deck after careful preparation including levelling with a grinder. The drain covers were prepared and set in place with Belzona® 4111. Belzona® 3121 was used to seal stress cuts in the pad after they were cleaned, dried and prepared with a concrete grinder.
