Belzona Gives New Life to Fan Blades

Industry: Chemical & Petrochemical
Application: FBC-Fans, Blowers and Compressors

Customer Location: Rayong, Thailand
Application Date: 2018

Substrate: FRP
Products: * Belzona 5111 (Ceramic Cladding),
* Superwrap II ,

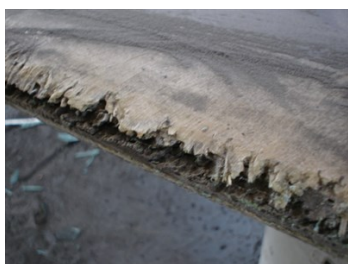
Deposit, erosion and mechanical damage of FRP fan blades for cooling tower were observed during turnaround period

* Lead Edge Damage Surface Preparation using Power tools application of Belzona 5111 Application of SWII ,

More than 1,400 pieces of fan blades were coated by Pan Mechanic Engineering with the Belzona 5911 and Belzona 5111 system. And recently we have also adapted Belzona SuperWrap II for repairing fan blades cracks because FRP fan blades need repair systems which have high strength and lightweight properties.
