Tank Base Sealing

Customer Location: Oiltanking Odjell Terminals & Company,
Sohar, Oman

Substrate: Storage Tanks (Petroleum, Chemical)

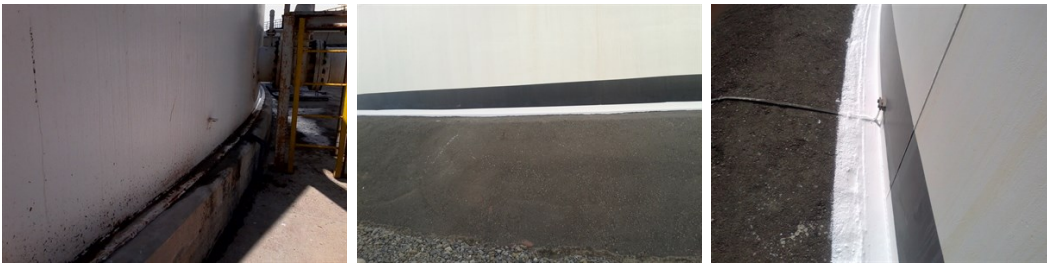
Due to the moisture ingress in the tank bottom side of the bottom plate annular ring area suffers corrosion and leads to material deterioration, thickness reduction and results to leakage. The client is looking for the long term solution to protect their 57 tanks.

* 1. Annular Plate condition before application 2. Completion of Tank Base Sealing 3. Close look of Tank Base Sealing ,

The application of Belzona 3111 – Flexible membrane system is carried in accordance with Belzona Know-How System Leaflet GSS-3.
