Belzona repairs leaking fire water pipe lines of a navy ship

ID: 7992

Products: * Belzona 1212 ,

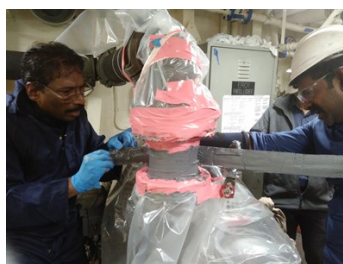
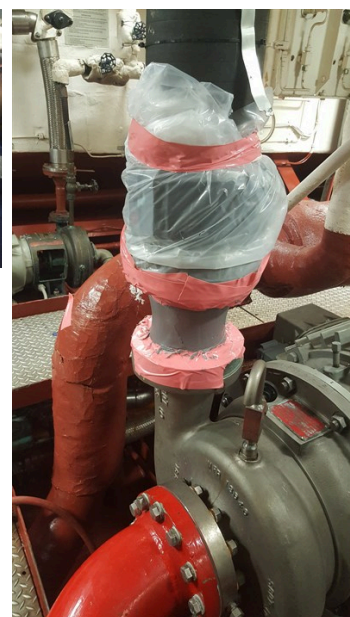
Photograph Descriptions

The pipe was leaking causing local flooding in the engine room. The navy tried to seal the leaking pipe with other products, but this had failed & was still leaking. So they contact Belzona

* 1) Leaking pipe 2) After surface preparation 3) Repair in progress 4) Completed application ,

The fire water pump piping was leaking with no replacement pipe available

The application was carried out in accordance with Belzona Know-How system Leaflet VPF 11
