HIGH CHROME PUMP RESTORED WITH BELZONA

Industry: Water / Wastewater
Application: CEP-Centrifugal Pumps
Substrate: High Chrome
Products: * Belzona 2911 (Elastomer QD Conditioner) ,
* Belzona 2111 (D&A High Build Elastomer) ,

Customer Location: Huelva - Spain
Application Date: September 2018

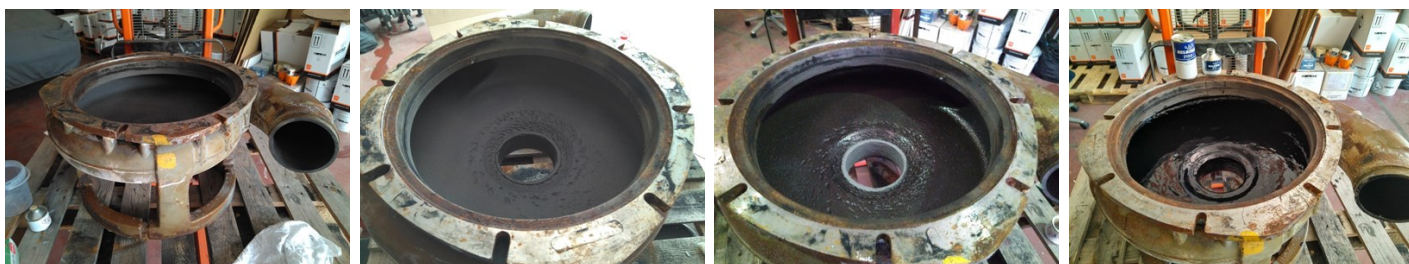
Photograph Descriptions

Despite the high hardness of the pump casing material, the high volume of solids in the process fluid has caused entrainment erosion.

- * 1. General view of equipment ,
- * 2. Eroded internal casing ,
- * 3. Belzona 2911 (Elastomer QD Conditioner) applied ,
- * 4. Completed application ,

The surface was cleaned with water and detergent to remove residues and impurities. A non-ferrous, angular grit was used to grit blast the surface to a near white metal finish, and to achieve a rough profile. Belzona 2911 (Elastomer QD Conditioner) was applied to the surface and allowed to become touch dry. During the overcoating window, Belzona 2111 (D&A) High Build Elastomer) was applied. The application was carried out in accordance with a modified version of Belzona System Leaflet CEP-03.

Belzona 2111 (D&A High Build Elastomer) was selected to form a protective barrier for the internal surface from the effects of erosion. The high build nature of the material meant a thick layer could be applied to the surface for extended service life, reducing future maintenance requirements. The Belzona solution was a fraction of the cost of replacement.
