# Belzona 1812 Saves Magnetic Wheel

ID: 7996

Industry: General Industry  
Application: SHM-Solids Handling Machinery

Restoring magnetic wheels in an ink factory.

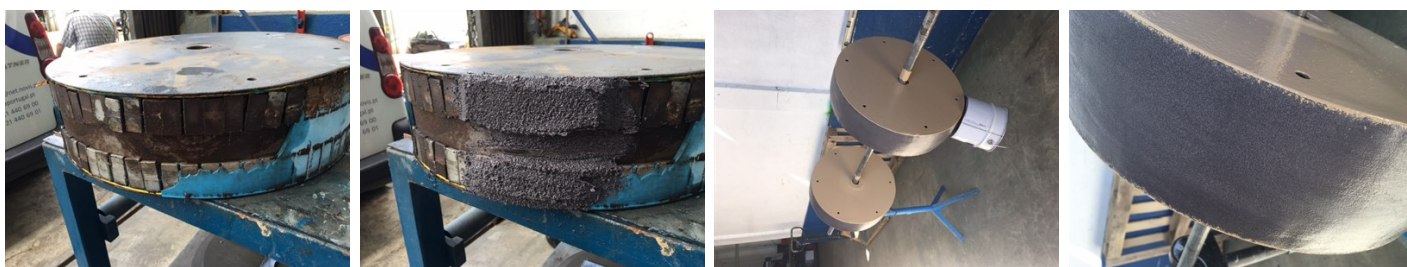
## Photograph Descriptions

Previous polyurethane coating failed due to impact from magnetically transporting heavy cans of ink from one conveyor belt to another. The customer needed a better solution, Belzona 1812 was chosen to carry out the application.

- \* 1. Damaged magnetic wheel with existing polyurethane coating ,
- \* 2. Belzona 1812 being applied ,
- \* 3. Restored magnetic wheel showing it's magnetic capabilities ,
- \* 4. Finished application ,

The application was completed in accordance with an adapted version of Belzona System Leaflet SHM\_12. A test patch of Belzona 1812 was applied to the wheel to see if the magnets would still work covered with Belzona. A 4 kg tin can magnetically stuck to the wheel so the application went ahead. The previous polyurethane coating was removed and the steel was then blasted before reinstalling the magnets and applying Belzona 1812. Acetone was used to make the wheel look smooth and the sides were coated with Belzona 5811 for aesthetic purposes before delivering to the customer.

The magnetic wheel is still in great conditions with no problems nearly 3 years on.
