# BELZONA FILLS THE VACUUM

Industry: Fluid Flow  
Application: CEP-Centrifugal Pumps  
Substrate: Stainless Steel  
Products: \* Belzona 4341 ,

Customer Location: Spain  
Application Date: June 2013

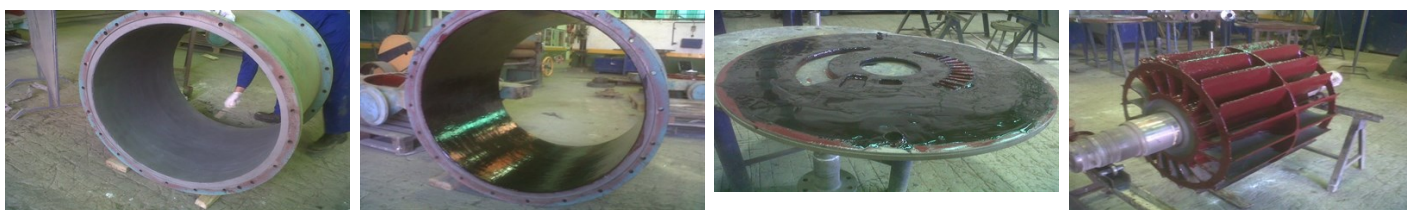
*Due to chemical attack caused by the sulfuric acid at elevated temperatures, the pump has lost material on all components. As a result the tolerances no longer provide an effective vacuum and the pump is running at low efficiency.*

- \* 1. Internal casing after preparation ,
- \* 2. Internal casing after coating ,
- \* 3. End covers coated ,
- \* 4. Impeller coated ,

After cleaning with a solvent degreaser to remove chemical residues, the surface was grit blasted to achieve a surface cleanliness in accordance with Swedish Standard SA 2.5 "Near White Metal". The entire internal surface, end covers, and impeller were coated with 2 layers of Belzona 4341. On the impeller tips, the coating was rebuilt to an excess of 5mm, then machined back to the required tolerances. The application was in accordance with a modified version of Belzona System Leaflet CEP-03 & CEP-07.

Belzona 4341 was chosen for its excellent resistance to inorganic acids at elevated temperatures. The 100% solids nature of the product meant that a precise thickness could be applied, easily allowing for the tolerances to be restored to the pump. The efficiency of the pump was fully regained, resulting in significant operating cost savings.
