# BELZONA SEALS DILUTED ACID LEAK

**Industry:** Chemical & Petrochemical  
**Application:** TCC-Tanks and Chemical Containment Areas

A sulfuric acid scrubber in an acid plant subject to contact with diluted sulfuric acid.

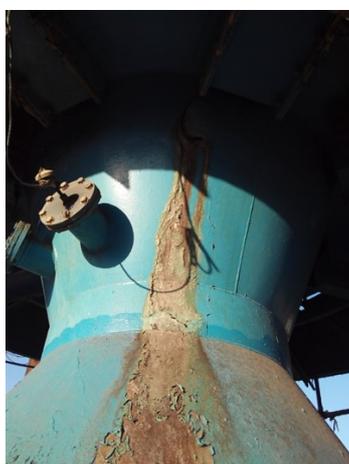
A small leak had developed at the top section of the scrubber. The resulting leak dripped down onto a lower area of the surface, causing damage to the external coating and resulting in an additional leak.

- \* 1. Leak caused by internal chemical attack ,
- \* 2. Damage caused by dripping acid ,
- \* 3. Surface preparation complete ,
- \* 4. Application complete ,

Loose metal was removed with mechanical tools until the surface was clean and had a rough profile. The repair area was decontaminated with acetone. Belzona 9611 (ES-Metal) was used to seal the live leaks. The small repair areas were covered with Belzona 4301 (Magma CR1 Hi-Build) & Belzona 9341 (Reinforcement Tape). In the larger repair areas, a PVC plate was bonded on with Belzona 4301 for additional strength. The application was completed in accordance with a modified version of Belzona System
