BELZONA SEALS ACTIVE LEAK

Customer Location: Pipeline Company in Louisiana, U.S.A.
Application Date: August 1996

36" Gate Valve holding back 27 miles of uphill diesel fuel.

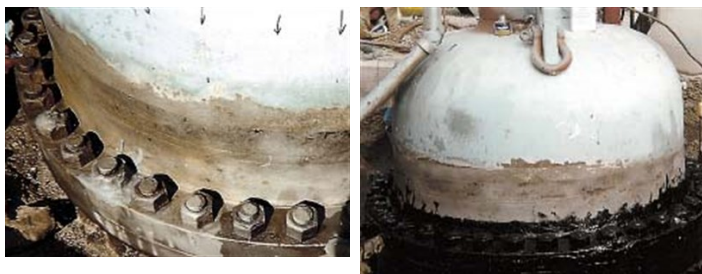
Fuel leaks at bolting areas between body and bonnet.

- * Surface cleaned and prepared. Belzona® 1221 (Super E-Metal) is used to seal the active leaks. ,
- * All bolts and flange were coated entirely with Belzona® 2131 (D&A Fluid Elastomer). ,

The application was carried out in accordance with a modified version of Belzona Know-How Leaflet GSS-3.
