Belzona Saves A Ruptured Effluent Tank

ID: 8000

Industry: Water / Wastewater
Application: TCC-Tanks and Chemical Containment Areas

Customer Location: Food Production Facility, UK
Application Date: October 2018

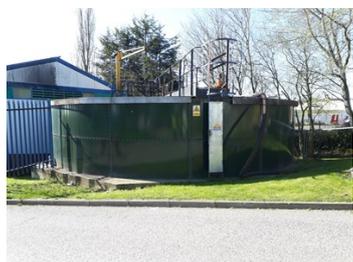
- * 1. Effluent treatment tank ,
- * 2. Extent of the leaks ,
- * 3. Plates bonded over repaired areas ,
- * 4. Sealed leaks around the base of tank ,

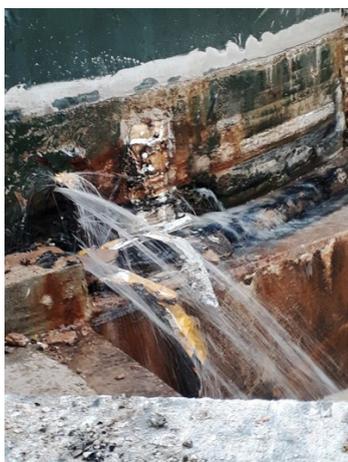
Corroded and through-wall defects on effluent tank created leaks in the system.

The leaks were plugged with wooden wedges to stem the flow. The areas around the leaks were then repaired with Belzona 9611 (ES-Metal). When the area was sealed, the wooden wedges were cut flush with the tank wall. They then bonded over the entire failed areas with Belzona 1111. Finally, when the Belzona 1111 had cured a bolt was screwed in, sealing the leaks. Belzona 1111 was also applied in a 75mm band around the base of the tank, incorporating reinforcing sheets, to seal the multiple leaks around the base. This was completed in accordance with Belzona system leaflet TCC-01.
