Belzona Repairs and Protects a Concrete Clarifier

ID: 8017

Application: FPA-Floor Problem Areas

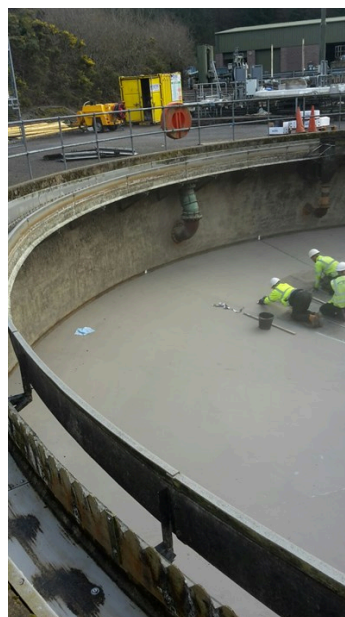
Placing screed rails

Belzona 4131 application by float

Application underway

The application was carried out in accordance with a modified version of Belzona KNow-How System Leaflet FPA-1. The concrete was first power washed and prepared mechanically. The clarifier was marked out into sections. Each section was then conditioned with Belzona 4911 and then 6mm of Belzona 4131 applied.

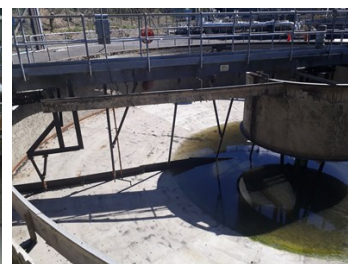
The tank drained one year on

mechanical strength and chemical resistance the original concrete. The tank was drained for a shutdown in May 2019 & found to be in a perfect condition.
