# BELZONA REPAIR TO TURBINE STATIONARY BLADE HOLDER

Customer Location: Geothermal Power Station in Indonesia  
Application Date: August, 2006

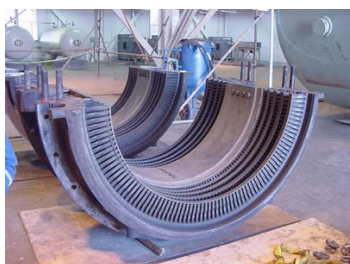
- \* View of the Stationary Blade Holders ,
- \* Typical damage found on the seating area after blasting ,
- \* Template in place to form the Belzona® 1111 ,
- \* Job completed with Belzona® 1591 ,

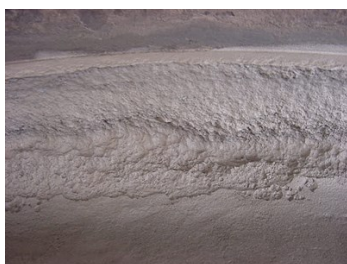
*Erosion-corrosion on seating area of the upper and lower halves of the stationary blade holder. This had been caused by many years exposure to saturated steam.*
