Belzona® Seals inside tank the steel shell to the concrete floor

ID: 8030

Industry: Oil & Gas
Application: TCC-Tanks and Chemical Containment Areas

Customer Location: Romania
Application Date: April 2018

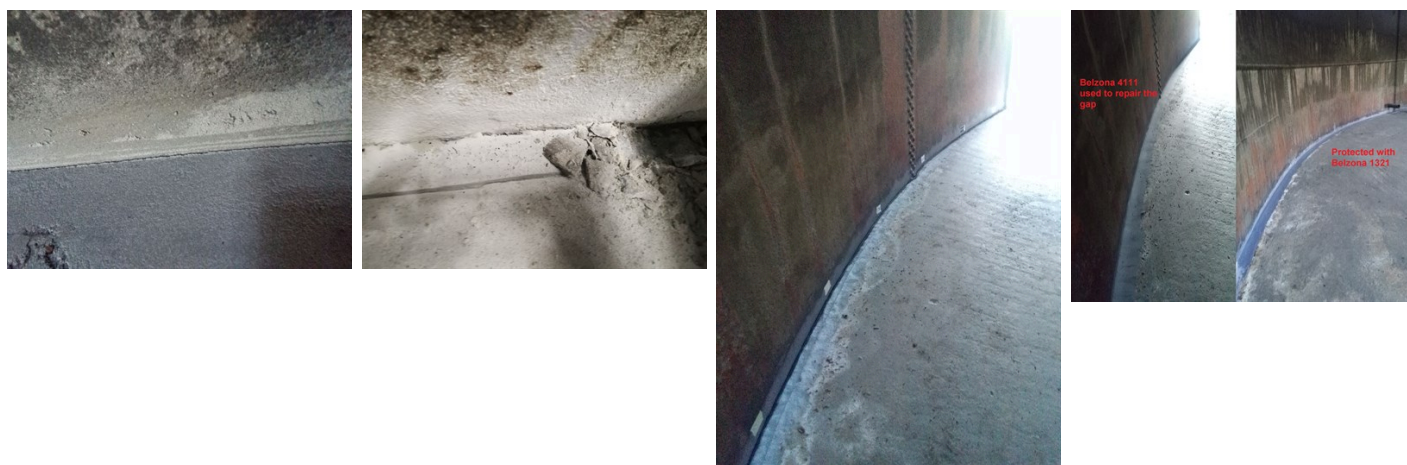
Photograph Descriptions

Between the concrete floor and the steel shell there was a gap of up to 6 mm that had to be sealed to stop the tank from leaking.

- * 1. Initial view of the gap between the tank shell and the concrete bottom. ,
- * 2. Surface preparation in progress. ,
- * 3. NBR rubber cord forced into the gap ,
- * 4. The finished application with Belzona 4111 applied on the left picture and the Belzona 1321 coating on the right picture. ,

In order to carry out the repair, the existing gap had to be enlarged, the contaminated concrete was removed, and the steel wall was cleaned and sandblasted, followed by degreasing the surface. In the existing gap a NBR rubber cord was inserted by force, and Belzona 4111 Magma Quartz was used to close the gap to the shell and restore the concrete thickness. The surface restored with Belzona 4111 Magma Quartz and the surrounding area on the steel shell where coated with a two coat system of Belzona 1321 Ceramic S-Metal, in order to provide corrosion protection.
