Belzona Concrete Tank Repair

Industry: Water / Wastewater
Application: TCC-Tanks and Chemical Containment Areas
Substrate: Concrete
Products: * Belzona 1161 ,
* Belzona 5831 ,

Customer Location: Lisbon
Application Date: April 2019

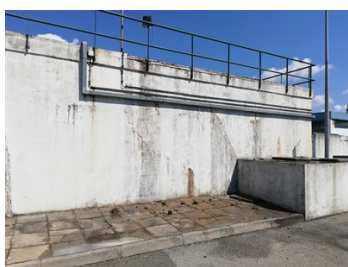
A large concrete tank used for supplying potable water for 3 of the neighboring cities was severely damaged internally. The cracked concrete was causing water to leak out of the external wall of the tank onto the road.

- * 1. External view of the concrete tanks ,
- * 2. Pressure washing/cleaning the concrete ,
- * 3. Filling in the damaged concrete with Belzona 1161 ,
- * 4. Coating of Belzona 5831 ,
