# Belzona Repairs Diesel Engine

ID: 8034

Industry: Oil & Gas  
Application: ENC-Engines and Casings  
Substrate: Cast iron  
Products: \* Belzona 1111 (Super Metal) ,

Customer Location: Croatia  
Application Date: July 2002

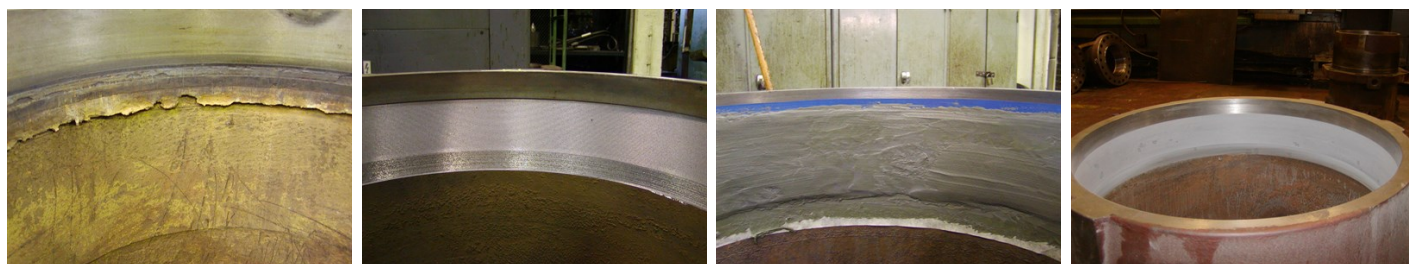
Pitting corrosion on engine block o-ring seats had caused failure.

- \* Damaged area ,
- \* Surface preparation ,
- \* Belzona 1111 rebuild ,
- \* Belzona 1111 machined ,

100 cylinders required repairing or would be replaced.

The application was carried out in accordance with a modified version of Belzona Know-How System Leaflet ENC-5.
