# Belzona Repairs Diesel Engine

ID: 8034

Industry: *Oil & Gas*  
 Application: *ENC-Engines and Casings*  
 Substrate: *Cast iron*  
 Products: *\* Belzona 1111 (Super Metal) ,*

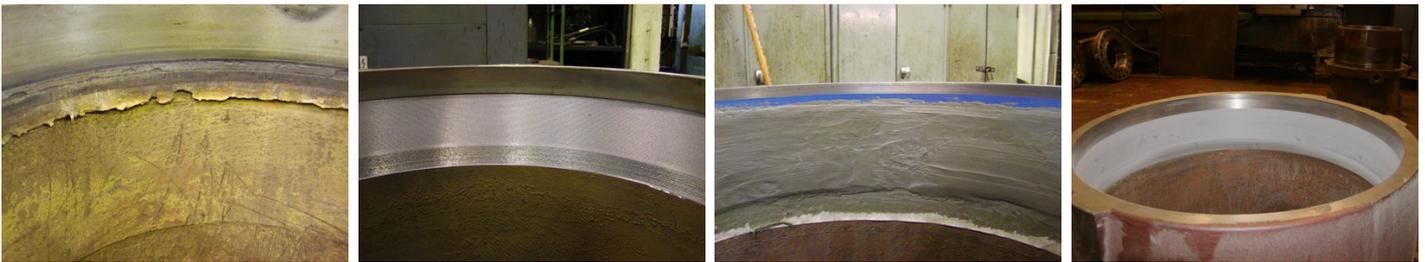
## Photograph Descriptions

*Pitting corrosion on engine block o-ring seats had caused failure.*

- \* Damaged area ,
- \* Surface preparation ,
- \* Belzona 1111 rebuild ,
- \* Belzona 1111 machined ,

100 cylinders required repairing or would be replaced.

The application was carried out in accordance with a modified version of Belzona Know-How System Leaflet ENC-5.

Customer is the biggest oil company in Croatia and this is an ongoing job since 2002 until today. No replacement was needed in all these years.
