Belzona Protects Risers

ID: 8035

Industry: Oil & Gas
Application: SOS-Ships and Offshore Structures

Customer Location: Offshore gas production platform
Application Date: July 2016

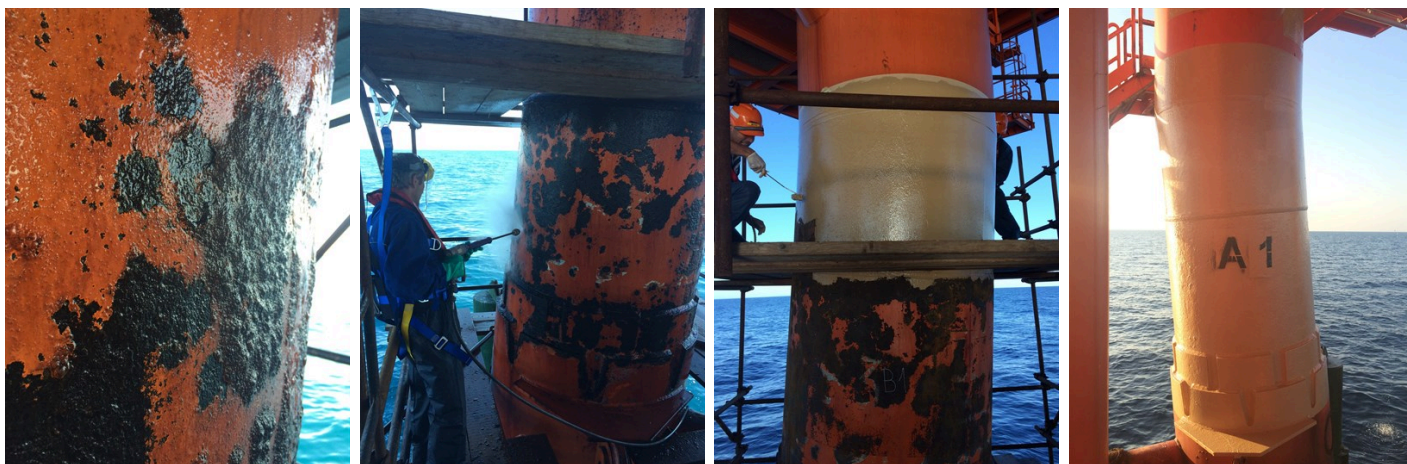
Photograph Descriptions

Damage to coating protection led to severe corrosion.

- * 1. Severe corrosion ,
- * 2. Surface preparation ,
- * 3. Application in progress ,
- * 4. Finished application ,

Severe sorrosion on gas offshore platform risers

Application was carried out using a modified version of Belzona Know-How System Leaflet SOS-21.

Belzona 5831 provides excelent adhesion on wet and minimal prepared surface and that fact makes this protection a very cost effective solution.
