# Belzona Protects Risers

ID: 8035

Industry: Oil & Gas  
Application: SOS-Ships and Offshore Structures

Customer Location: Offshore gas production platform  
Application Date: July 2016

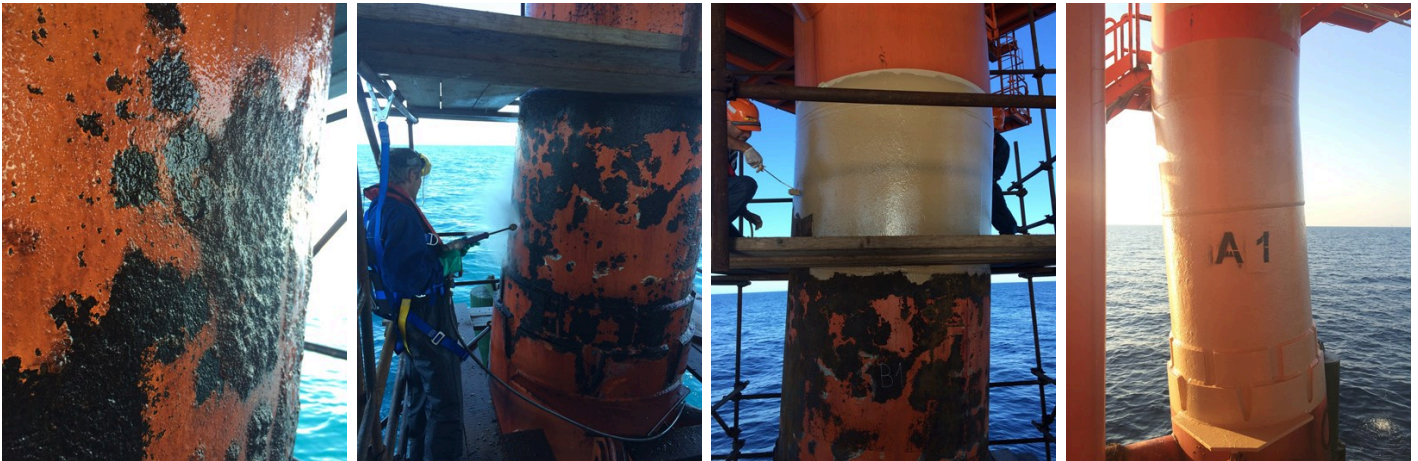
## Photograph Descriptions

Damage to coating protection led to severe corrosion.

- \* 1. Severe corrosion ,
- \* 2. Surface preparation ,
- \* 3. Application in progress ,
- \* 4. Finished application ,

Severe sorrosion on gas offshore platform risers

Application was carried out using a modified version of Belzona Know-How System Leaflet SOS-21.

Belzona 5831 provides excelent adhesion on wet and minimal prepared surface and that fact makes this protection a very cost effective solution.
