# BELZONA REPAIR TO TURBINE STATIONARY BLADE HOLDER CASING

ID: 804

Customer Location: Geothermal Power Station in Indonesia  
Application Date: August 2006

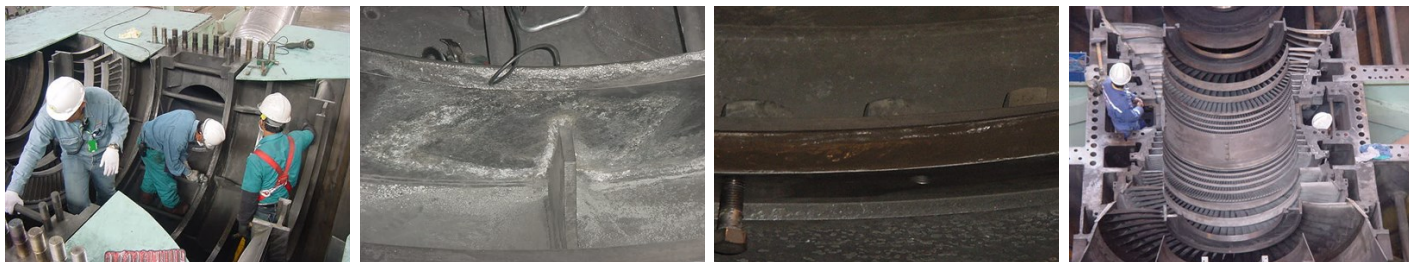
*Erosion-corrosion of the Turbine Casing, top and bottom seating area for the Stationary Blade Holder.*

\* View of Turbine Casing , \* Typical damage found on the seating area for the Stationary Blade Holder , \* Application of Belzona 1591 on seating area , \* Job completed with stationary blade holder installed in turbine casing ,

Application was carried out in accordance with Belzona Know How System Leaflets CEP-3 & CEP-5.
