BELZONA REPAIR TO TURBINE STATIONARY BLADE HOLDER CASING

ID: 804

Customer Location: Geothermal Power Station in Indonesia
Application Date: August 2006

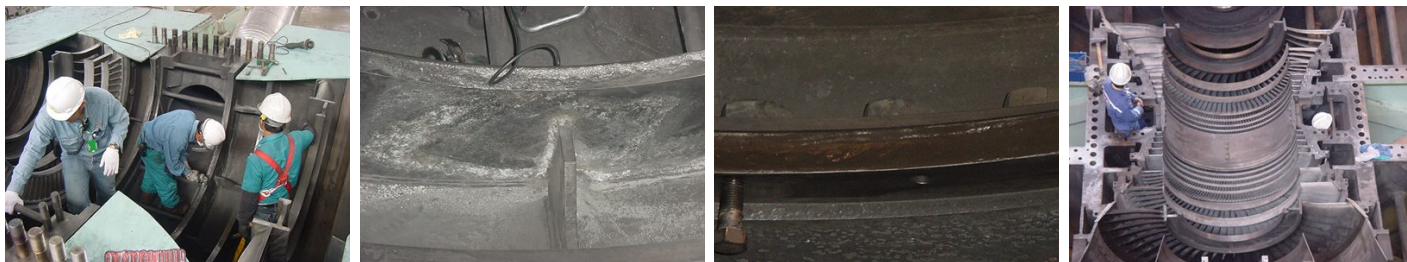
Erosion-corrosion of the Turbine Casing, top and bottom seating area for the Stationary Blade Holder.

* View of Turbine Casing , * Typical damage found on the seating area for the Stationary Blade Holder , * Application of Belzona 1591 on seating area , * Job completed with stationary blade holder installed in turbine casing ,

Application was carried out in accordance with Belzona Know How System Leaflets CEP-3 & CEP-5.
