Belzona Superwrap II saves FPSO

Industry: Oil & Gas
Application: VPF-Valves, Pipes and Fittings
Substrate: Carbon Steel
Products: * Belzona 1121 (XL-Metal) ,
* Belzona 1982 (SuperWrap II) ,

Customer Location: Ivory Coast
Application Date: May 2019

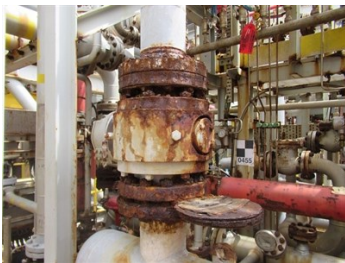
Corroded flange and fasteners on the High Pressure Fuel Gas Heater inlet and outlet. The operating pressure of the heater is 24 bar at 30°C on the inlet and 36°C on the outlet. Client could not afford for the flange or bolts to leak and be shutdown as would be very costly to them. The client required protection of the system for 9 months until the next shutdown, where the entire unit would be replaced.

* 1. Condition of Flanges and valve 2. Design output 3. During application of Inlet 4. Finished application ,
