# Belzona Superwrap II saves FPSO

Industry: Oil & Gas  
Application: VPF-Valves, Pipes and Fittings  
Substrate: Carbon Steel  
Products: \* Belzona 1121 (XL-Metal) ,  
\* Belzona 1982 (SuperWrap II) ,

Customer Location: Ivory Coast  
Application Date: May 2019

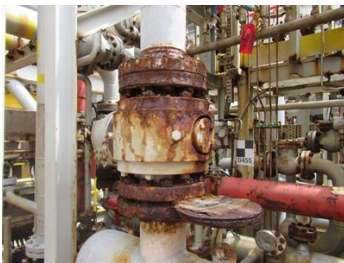
Corroded flange and fasteners on the High Pressure Fuel Gas Heater inlet and outlet. The operating pressure of the heater is 24 bar at 30°C on the inlet and 36°C on the outlet. Client could not afford for the flange or bolts to leak and be shutdown as would be very costly to them. The client required protection of the system for 9 months until the next shutdown, where the entire unit would be replaced.

\* 1. Condition of Flanges and valve 2. Design output 3. During application of Inlet 4. Finished application ,
