# Belzona Repairs Conductor Casing On Offshore Platform

ID: 8045

Substrate: Wellhead conductor and casing - carbon steel

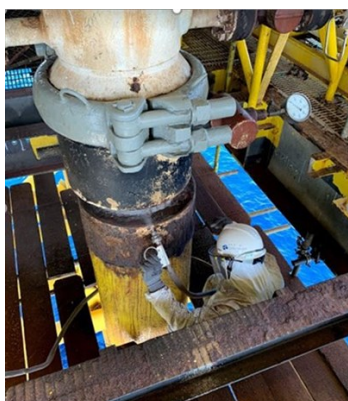
- \* Surface preparation by blasting ,
- \* Pouring Belzona 7111 ,
- \* Sealing with Belzona 3411 ,
- \* Finished Application ,

Belzona 7111 was poured to fill the void and was then sealed with Belzona 3411.
