Belzona Repairs Conductor Casing On Offshore Platform

ID: 8045

Substrate: Wellhead conductor and casing - carbon steel

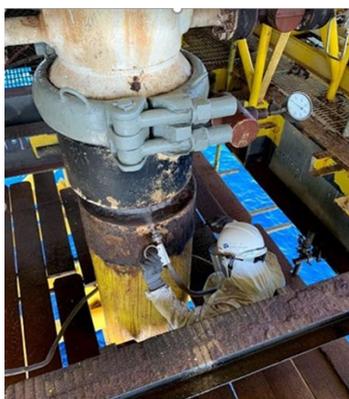
The cavity between the well head and conductor casing corrodes, vibrates, and becomes misaligned. The engineers performed an analysis that showed very high concentrated stress levels and loads acting on the cavity.

- * Surface preparation by blasting ,
- * Pouring Belzona 7111 ,
- * Sealing with Belzona 3411 ,
- * Finished Application ,

Belzona 7111 was poured to fill the void and was then sealed with Belzona 3411.
