Belzona Cold Plate Bonding Reinforces Offshore Weather Deck

ID: 8046

Customer Location: North Sea - Norway
Application Date: March 2019

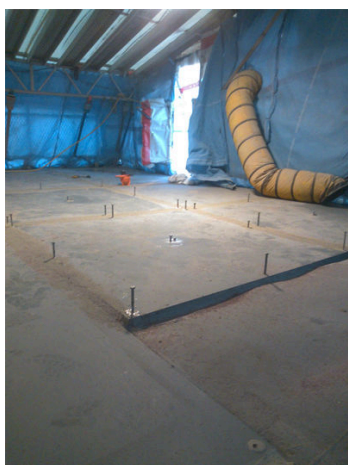
- * 1. Positioning of Deck Plates. ,
- * 2. Sealing of deck repair plates with Belzona 1111 (Super Metal) ,
- * 3. Injecting Belzona 5811 (Immersion Grade) between repair plate and deck. ,
- * 4. Completed application. ,

The application was carried out in accordance with a Belzona system Leaflet GSS-9 Creating Irregular Shims. All through wall holes on the deck were repaired and sealed with Belzona 1111 (Super Metal) Following gritblasting of manufactured steel plates (various sizes from 1x1metres to 1.6x1.6 metres) and weatherdeck, the plates were positioned and leveled using jacking bolts. The edges of the plates were sealed using Belzona 1111 (Super Metal). Belzona 5811 (Immersion Grade) was injected by single component airless spray into the crevice between the existing deck and reinforcement plate.
