Belzona helps in the Restoration of an Irrigation Pipeline

ID: 8049

Customer Location: Italy
Application Date: May 2019

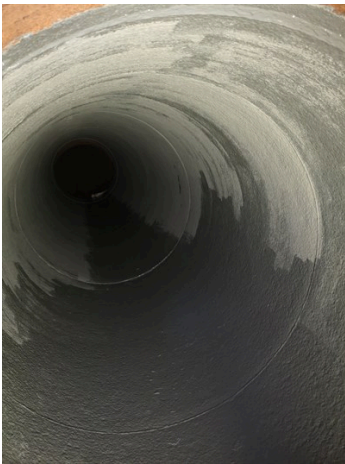
- * View after sandblasting ,
- * Application of Belzona 1121 ,
- * Application of Belzona 1982/9381 ,
- * Application of Belzona 5821 ,

This application was carried out in accordance with system leaflet TCC-05. The internal walls of the pipeline were sandblasted and

then any pitted areas were filled in with Belzona 1121. A Belzona SW2 system was then fabriacted to create a "pipe within a pipe" to restore the existing pipeline. Finally 2 coats of Belzona 5821 was applied over the SW2 system to provide corrosion and erosion resistance.
