Strengthening of a Storage Tank with Belzona SuperWrap II

ID: 8055

Industry: Oil & Gas

Application: VPF-Valves, Pipes and Fittings

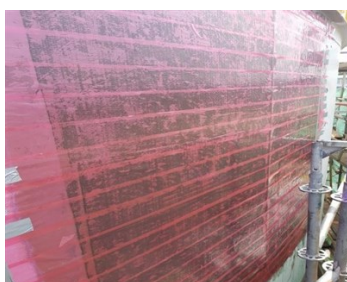
Storage Tank shell deterioration and the wall of the tank thinning. Restoration of stiffness and nominal strength of the tank's shell.

- * Belzona 9381 Superwrap II Applied ,
- * Belzona 9382 - Release Film Applied ,
- * Belzona 9382 - Release Film Applied ,
- * Belzona Superwrap II Complete ,

The application was completed in accordance with Belzona System Leaflet VPF-11. The substrate was prepared and degreased. Belzona 9381 Reinforcement Sheet was wet out with the Belzona 1981 resins as well as the substrate. Belzona 9382 was applied to consolidate the repair.
