Hydroelectric Generating Station Scroll Tunnel

Customer Location: Hydroelectric power station, Alabama, USA

Application: WPA-Wall Problem Areas

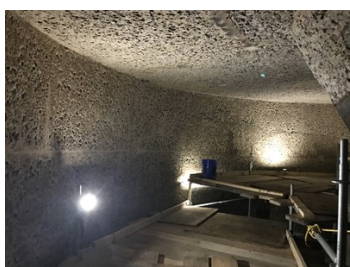
The concrete scroll tunnel walls, floor, and ceiling were deteriorating due to many years of operation. Total area to be treated was 9000 sq. ft. Belzona 4141 lightweight Magma Build was used to restore the ceilings up to 2" thick in areas. The walls and floor were repaired with Belzona 4131 Magma Screed. After restoring the concrete, Belzona 5811 immersion grade barrier coating the was used protect the entire area .

Concrete deterioration

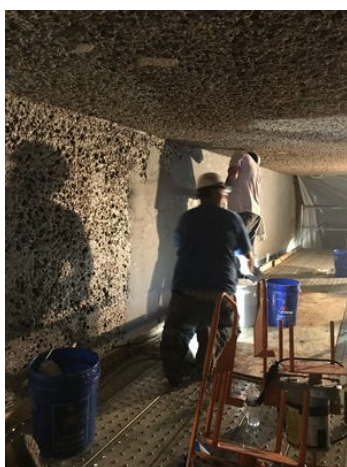
Rebuilding concrete with 4131

The ceilings were rebuilt with Belzona 4141 following system leaflet WPA-04 and the walls and floor were repaired using Belzona 4131 following system leaflet WPA-04 and FPA-01.

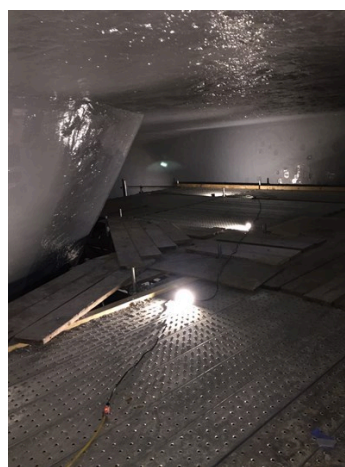
Tunnel coated with 5811

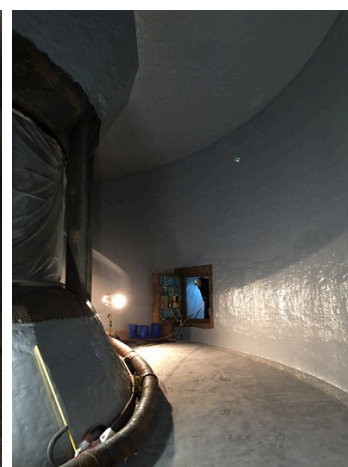
Finished results
